FLOOD PLAIN INFORMATION

FLOOD PLAIN
MANAGEMENT SERVICES
NEW ENGLAND DIVISION
CORPS OF ENGINEERS

WHITE RIVER,
SECOND BRANCH, THIRD BRANCH & AYERS BROOK,
RANDOLPH AND BETHEL, VERMONT

DECEMBER 1973

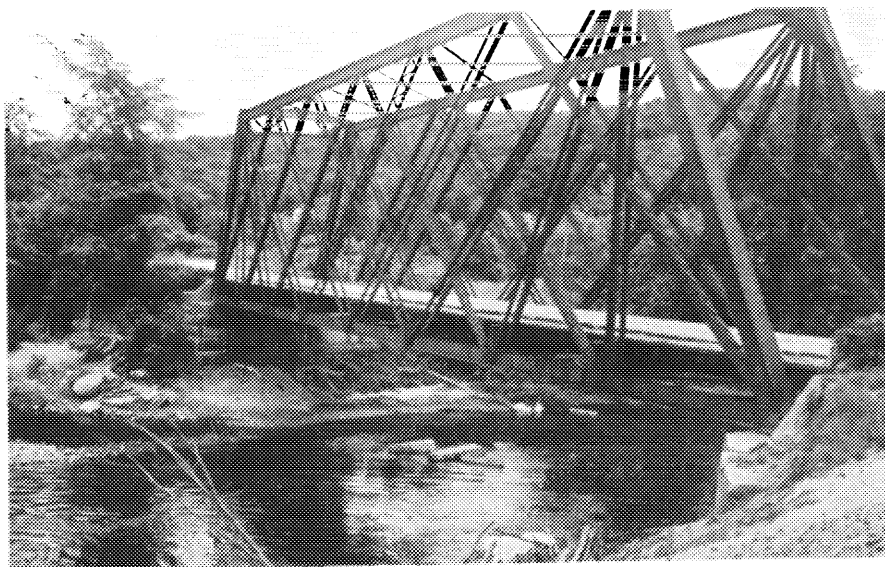
Figure 1 - Third Branch - Town road bridge, Bethel, at Mile 0.2.

Obstructions to floodflows - Natural obstructions to floodflows include trees, brush and other vegetation growing along the streambanks in flood plain areas. Manmade encroachments on, or over, the streams such as dams, bridges, culverts and indiscriminate filling in the flood plains can also create more extensive flooding than would otherwise occur. See figures 1 through 4 for representative obstructions.

The streams in the study area are spanned 25 times by bridges. Pertinent information on all bridges can be found in Table 6. Some bridges are obstructions to flood flows. Photographs of four of these bridges are shown in Figures 1 thru 4.

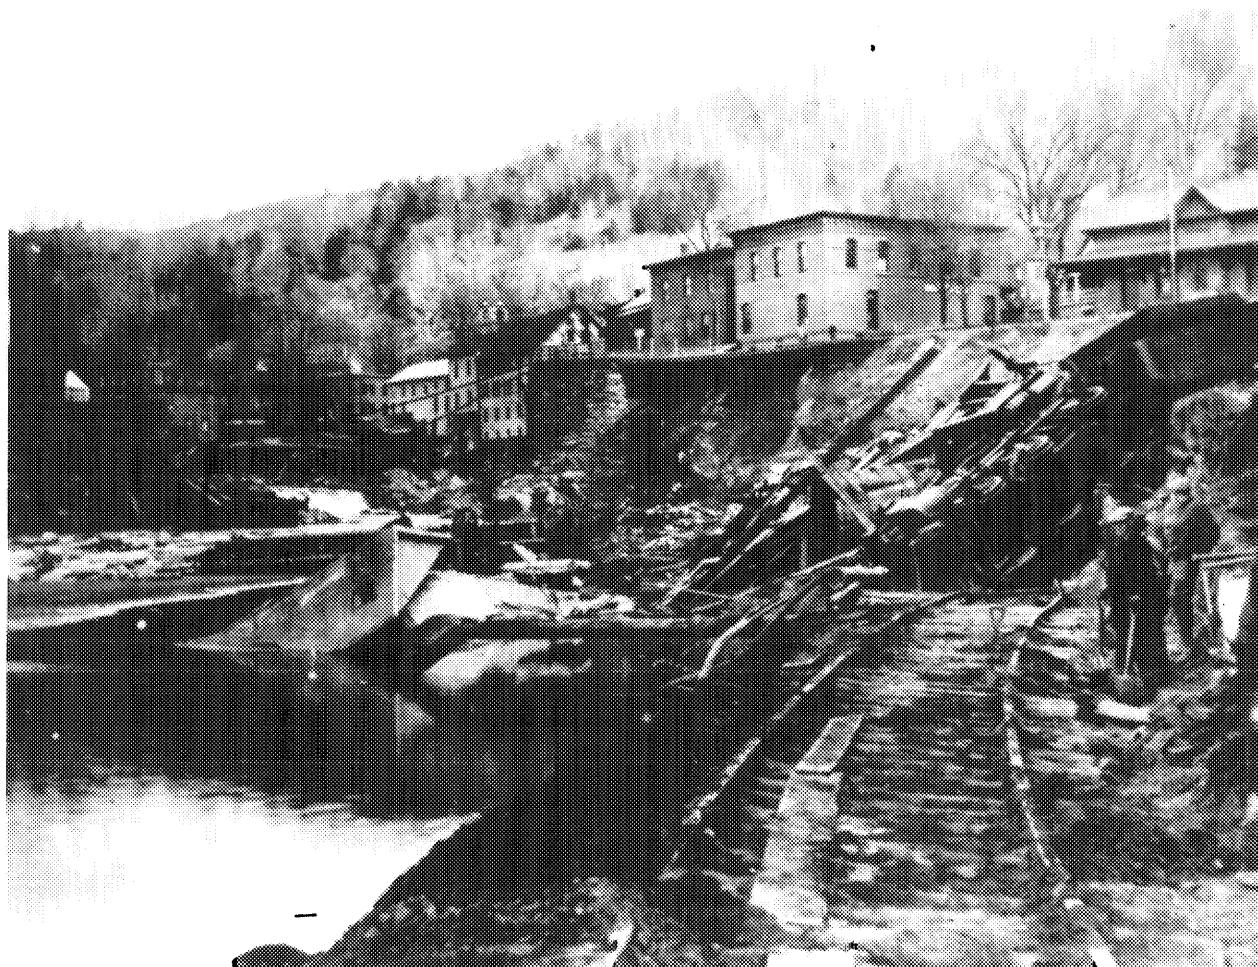
Figure 6 - Bethel - November 1927 flood. Damage along the Third Branch looking upstream.

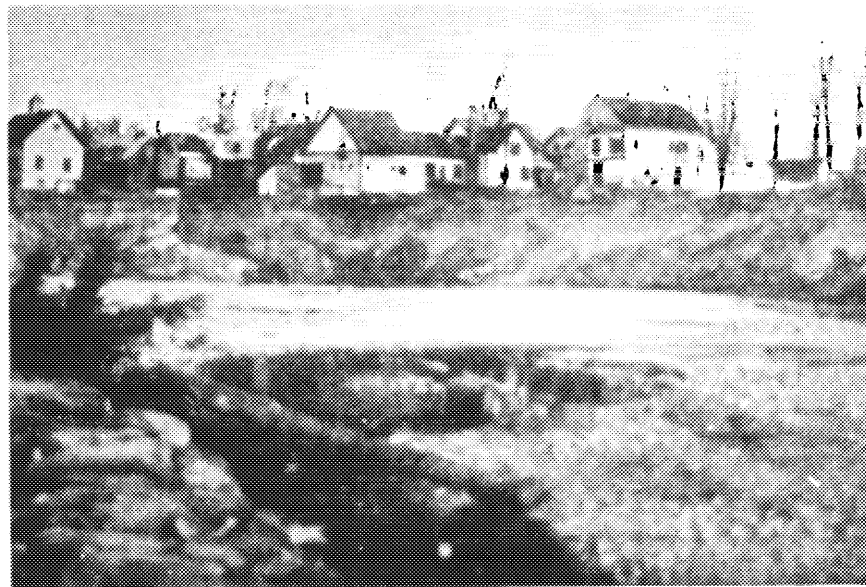
Figure 8 - Randolph - November 1927 Flood. Rear of School Street showing vast bank erosion.

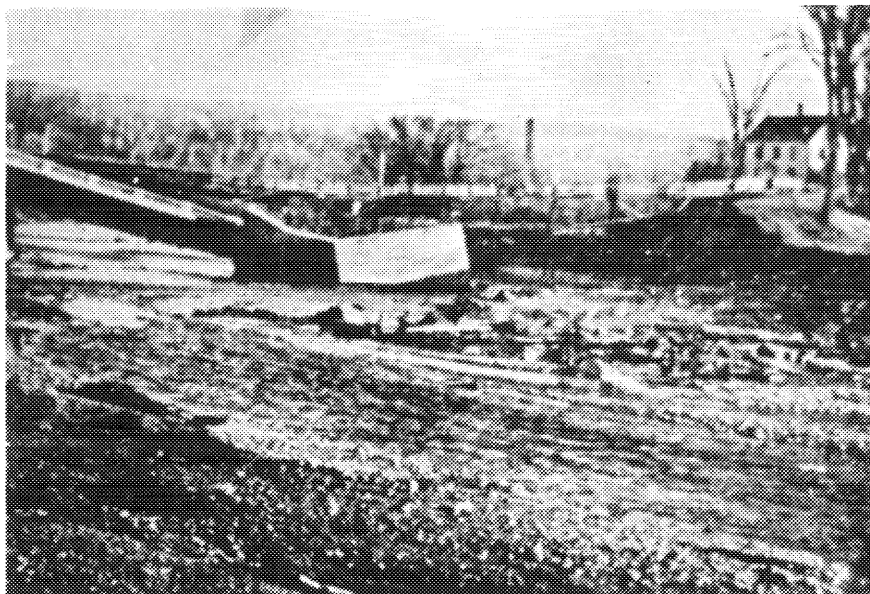
Figure 9 - Randolph - November 1927 Flood. Destruction of the former Main Street bridge, new at the time.

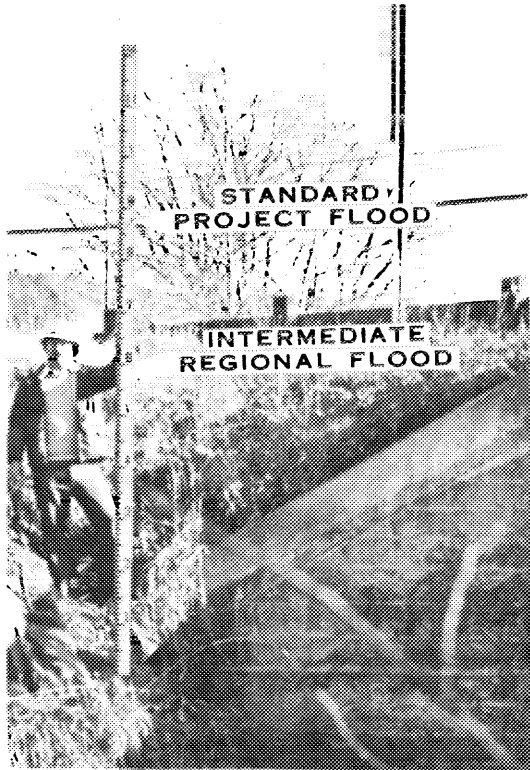
Figure 12 - Future flood heights at Central Street bridge, Randolph.

Photographs, future flood heights - The levels that the Intermediate Regional and Standard Project Floods are expected to reach at various locations in the study area are indicated on the following photographs (see Figures 10 through 14):
